12/14/94 Phoenix Air Group, Inc.

Official Accident Report Index Page

CRASH DURING EMERGENCY LANDING
PHOENIX AIR LEARJET 35A, N521PA FRESNO,
CALIFORNIA DECEMBER 14, 1994

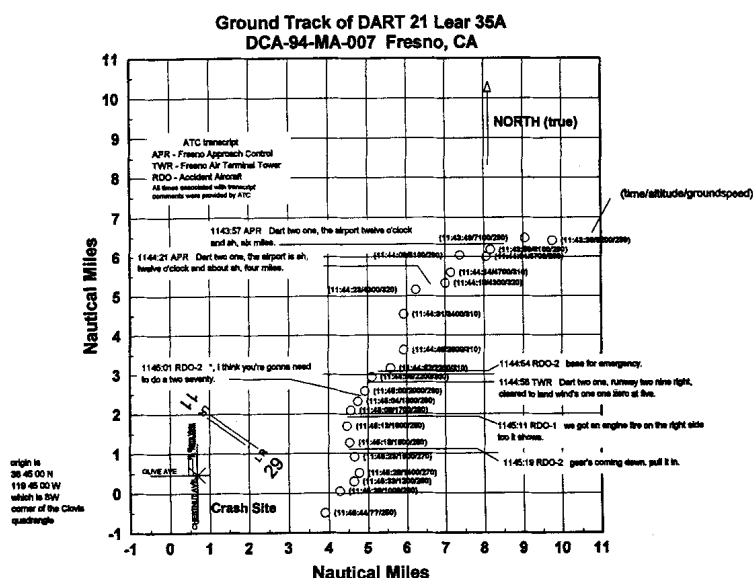
Figure 1a.--Ground track.

About 1145:01, as Dart 21 was about 3 miles east-northeast of the approach end of 29R, on a track toward the southwest (see ground track and flight profile, from NAS Lemoore radar data and Fresno tower radio transmissions, [figure 1a](#), [figure 1b](#), [figure 1c](#)), the first officer stated, "I think you're gonna need to do a two seventy." At 1145:11, the captain stated, "we got an engine fire on the right side too, it shows." Radar data show that the airplane was flying at 280 knots ground speed, about 1,600 feet msl (the field elevation of FAT is 333 feet msl).
